SUBJECT: Soft Top Material Pulls Away From Rear Window Trim

MODELS: E30 and E36 Convertibles

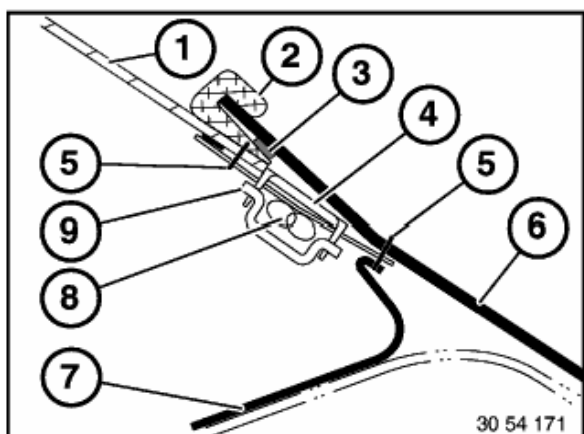
Situation: Convertible tops, both original equipment and replacement parts, with a zip-in rear window may have the top material pull out of the plastic channel of the rear window trim, especially at the fold points. Once the material has pulled away, the adhesive strip around the rear window loses its stickiness, and the material will not stay in place.

Tops and replacement rear windows made after 7/94 have a wider plastic channel (Item number 2 in illustration) that covers more of the top material, which prevents this problem.

The material that the channel is made out of was also improved so that it is more flexible.

Correction: **In case of customer complaint**, an attempt to repair the window currently in the top should be made.

- Unlatch the top to release the tension on the top material.
- Carefully clean the inside of the top material and the adhesive strip in the area where the material is loose with mineral spirits, and allow to dry.
- Brush an even coat of convertible top adhesive (BMW part number 81 22 9 407 524 or 3M number 1357) inside the top material and on the adhesive strip. Allow the adhesive to dry for about 10 minutes, and then press the top material back in place, inserting the edge of the material into the plastic channel. Put pressure on the inside of the soft top and rub vigorously on the outside to set the adhesive.

If for some reason the above repair does not last, the rear window should be replaced.

Carefully clean off all old adhesive inside the top material before installing the new window.
