SUBJECT: E-M Top Frame Breaking

325i Convertible

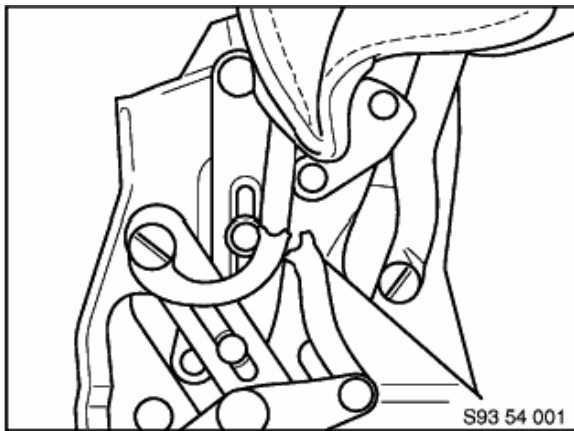
The additional arm welded to the rear window (number 5) bow of the EM soft top frame can break in the area of the screw hole. This area has been strengthened in production as of 11/92.

Since this arm was not available separately, replacement of the entire frame was the normal repair method in the past. However, the arm is now available as a replacement part.
