**SUBJECT:           Soft Top Material Rubs on Tension Spring Mount**

325i Convertible (E30) with EM Soft Top

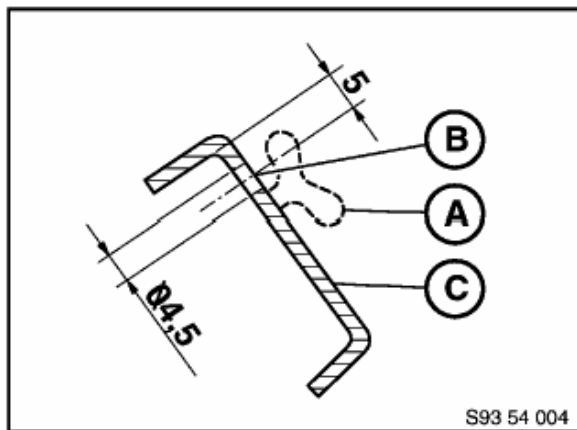
When folded, the soft top material can rub up against the "T" bar mount that anchors the right side tension spring. After a period of time the top can be rubbed through.

- Open the top partially to release the tension on the spring.
- Disconnect the spring from the "T" bar, and break the "T" (A) bar off of the frame.
- Pull the window seal partially out of the seal rail, and drill a 4.5mm hole (B), 5mm in from the edge of the frame (C), next to where the "T" bar was.

- Fasten the tension spring to the frame with a 4mm rivet (part number 07 12 9 948 753) and reinstall the window seal.
